**ANNUAL CCR UNIT INSPECTION REPORT
2025**

**NEW CASTLE STATION ASH LANDFILL
WEST PITTSBURG, LAWRENCE COUNTY, PENNSYLVANIA**

**INSPECTION DATE: 12/23/2025
REPORT DATE: 1/9/2026**

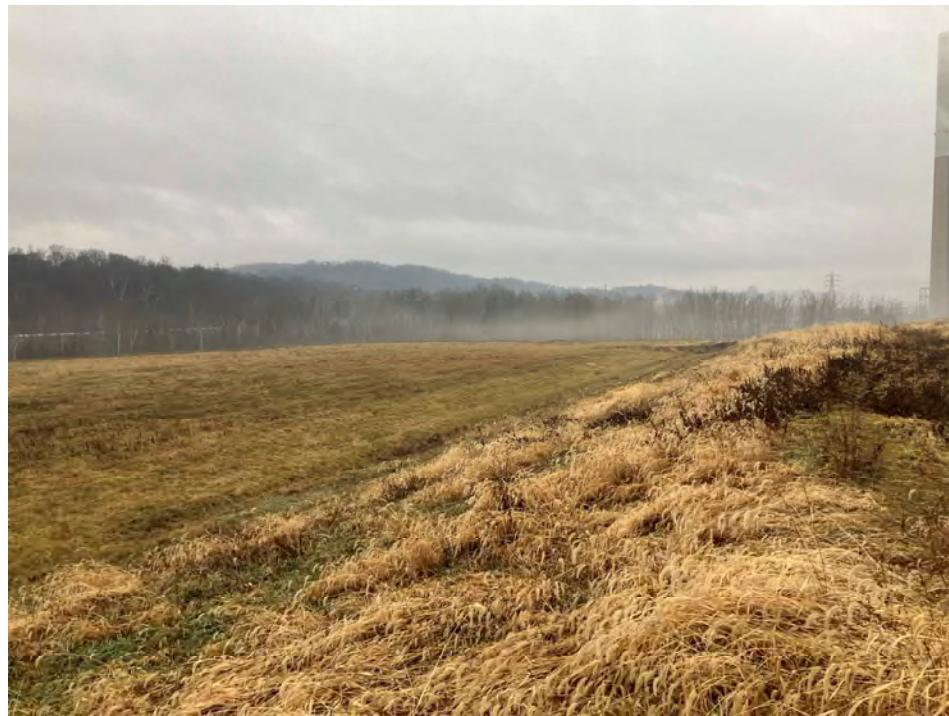
Photograph 1: Stage 6 final cover is well vegetated and mowed annually. No evidence of animal burrows, erosion, or stability issues.

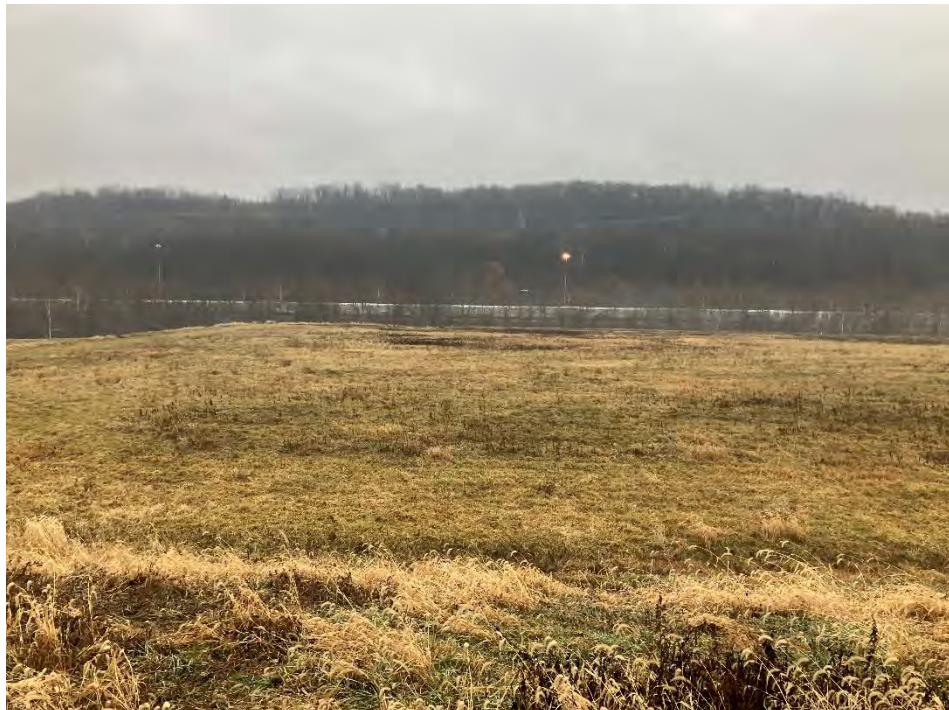
Photograph 2: Stage 5/Stage 6 final cover is well vegetated and mowed annually. No evidence of animal burrows, erosion, or stability issues.

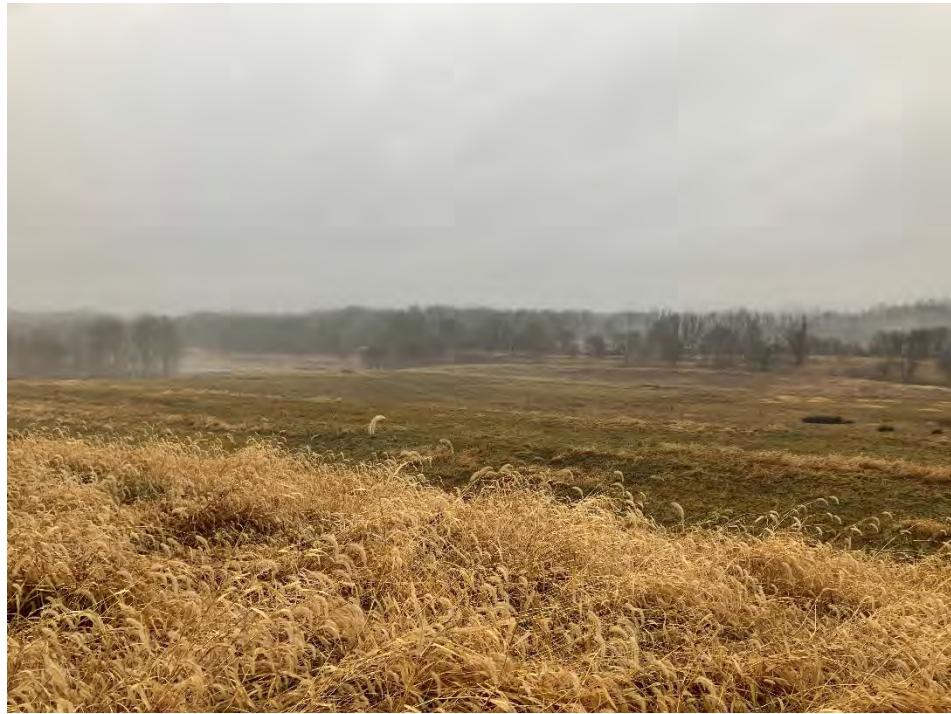
Photograph 3: Stage 5 final cover is well vegetated and mowed annually. No evidence of animal burrows, erosion, or stability issues.

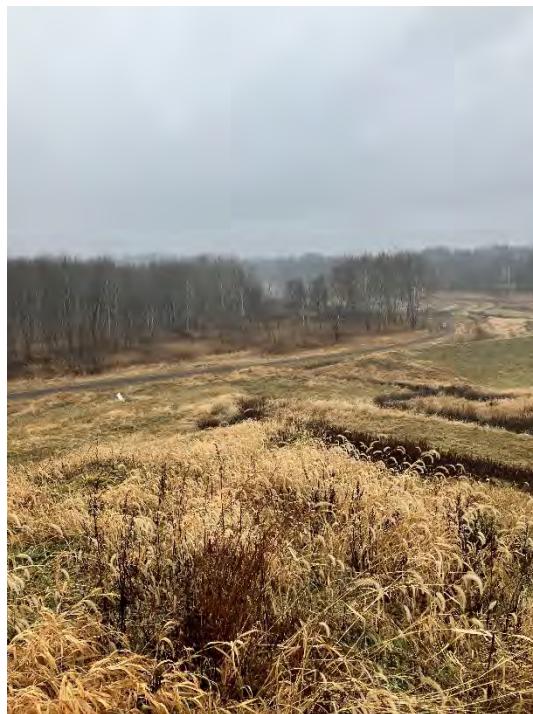
Photograph 4: Downchutes from west side of Stage 4 and Stage 5. No evidence of animal burrows, erosion, or stability issues.

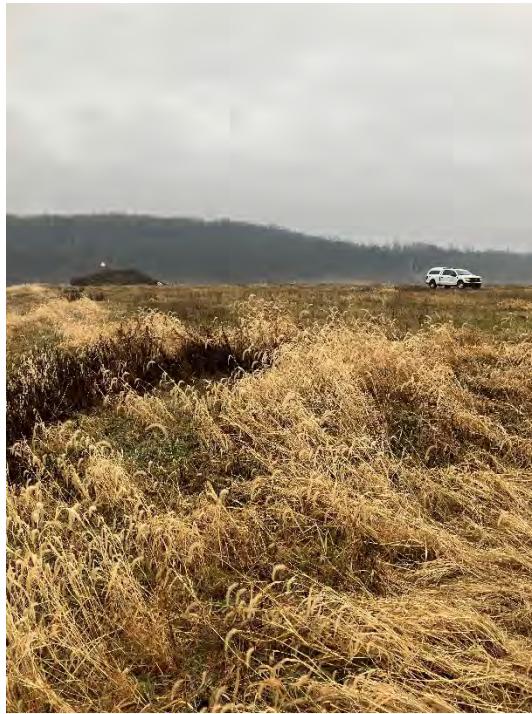
Photograph 5: Stage 4 west slope is well vegetated and mowed annually. No evidence of animal burrows, erosion, or stability issues.

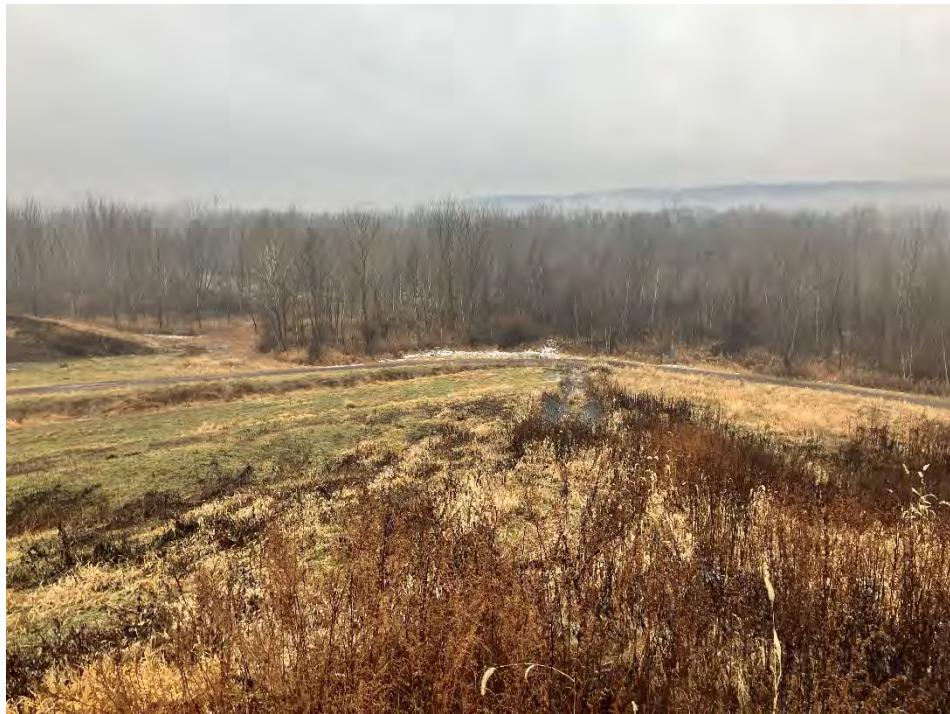
Photograph 6: Stage 4 southwest corner slope and downchute is well vegetated and mowed annually. No evidence of animal burrows, erosion, or stability issues.

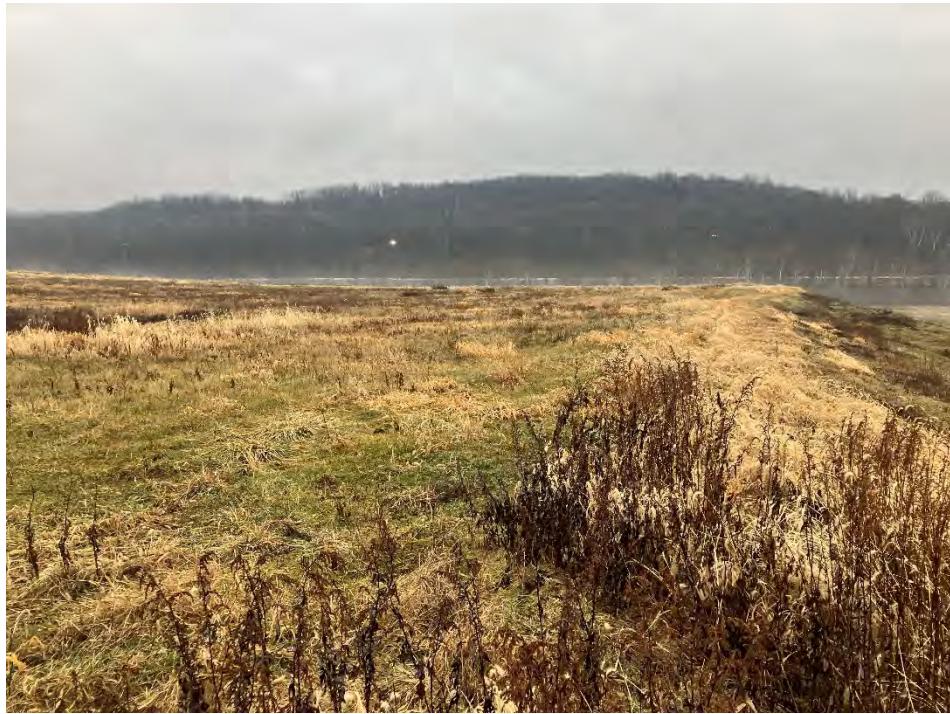
Photograph 7: Stage 4 south slope is well vegetated and mowed annually. No evidence of animal burrows, erosion, or stability issues.

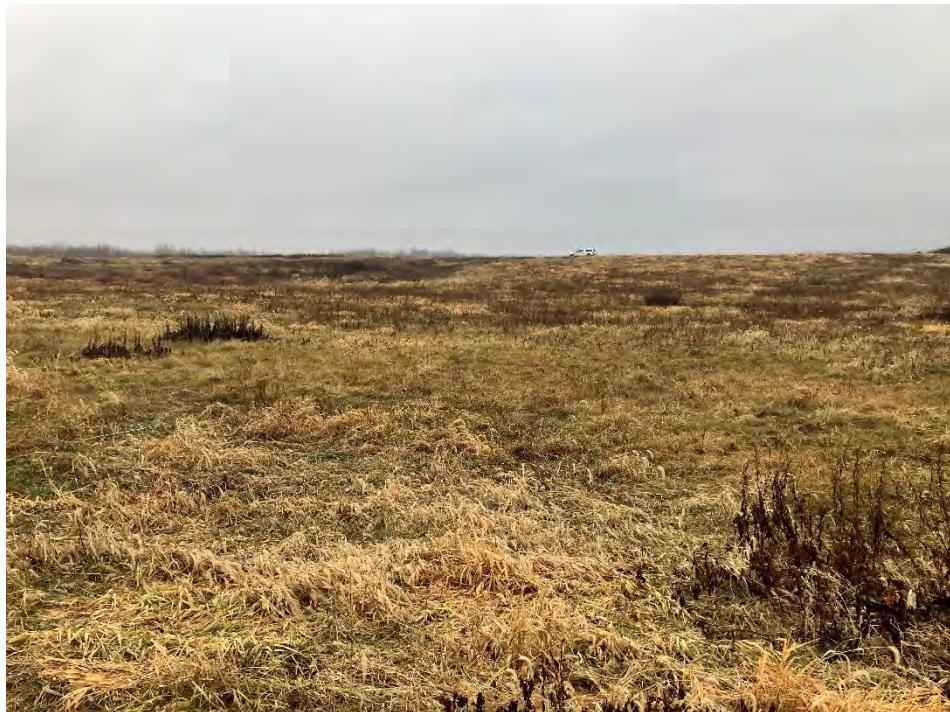
Photograph 8: Intermediate cover in Stage 4 active area looking northwest is well vegetated and mowed annually.

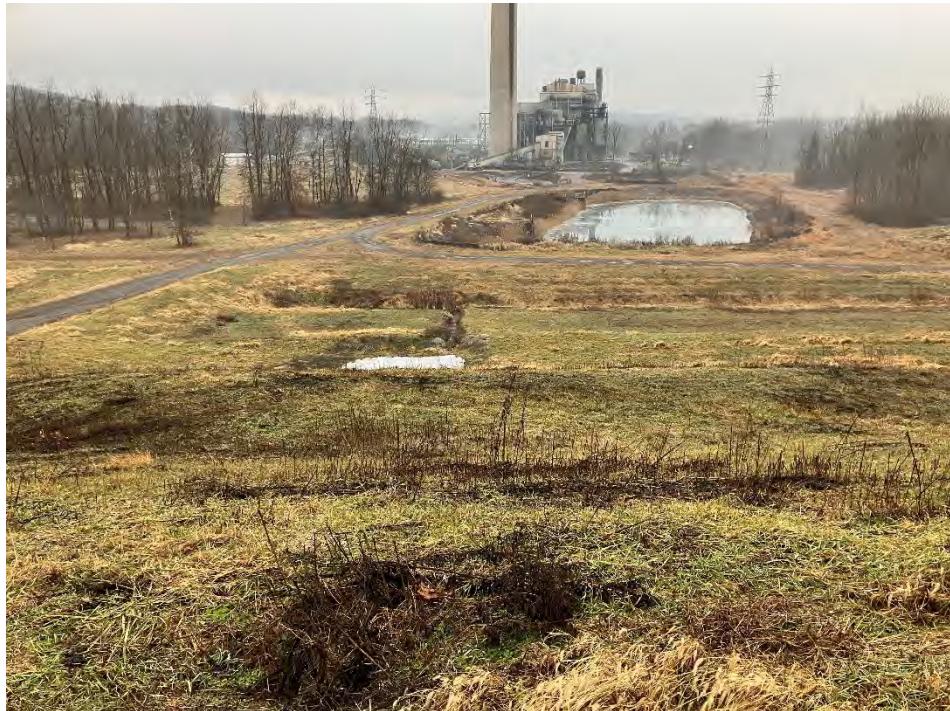
Photograph 9: Stage 4 south slope is well vegetated and mowed annually. No evidence of animal burrows, erosion, or stability issues.

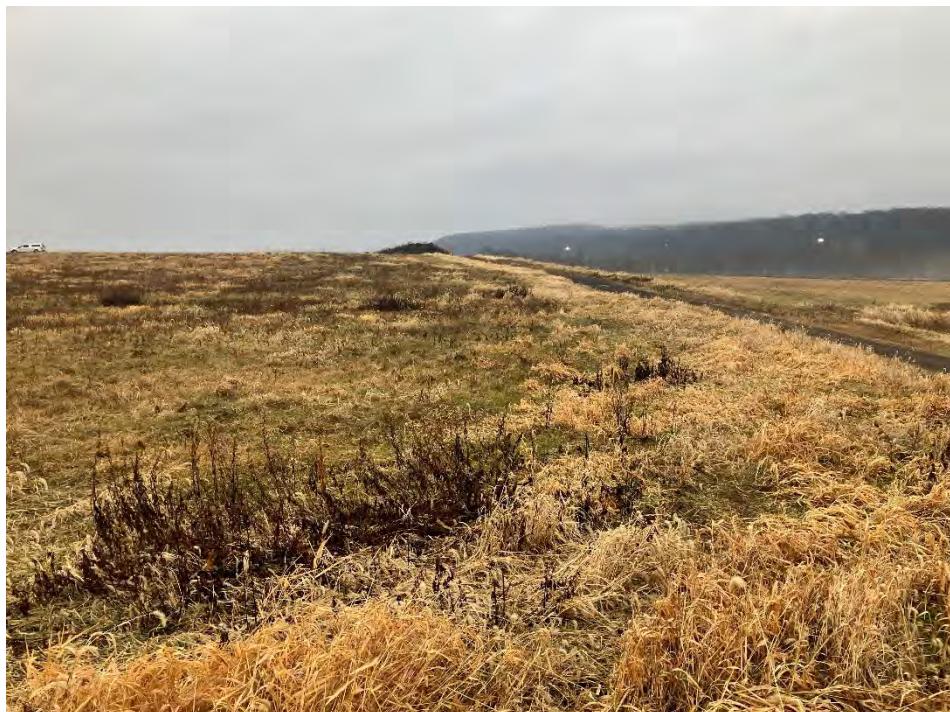
Photograph 10: Intermediate cover area in Stage 4 active area /Stage 6 final cover is well vegetated and mowed annually.

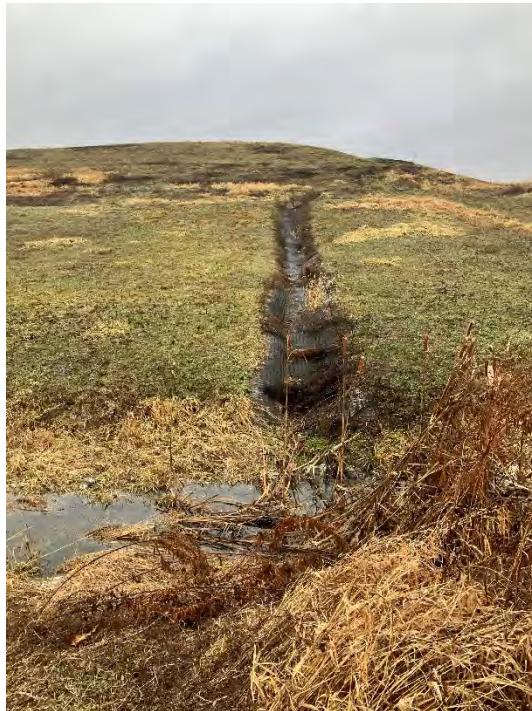
Photograph 11: Non-contact stormwater downchute on south slope is clear of obstructions. Gabion energy dissipator is installed at the junction with the stormwater (non-contact water) perimeter ditch.

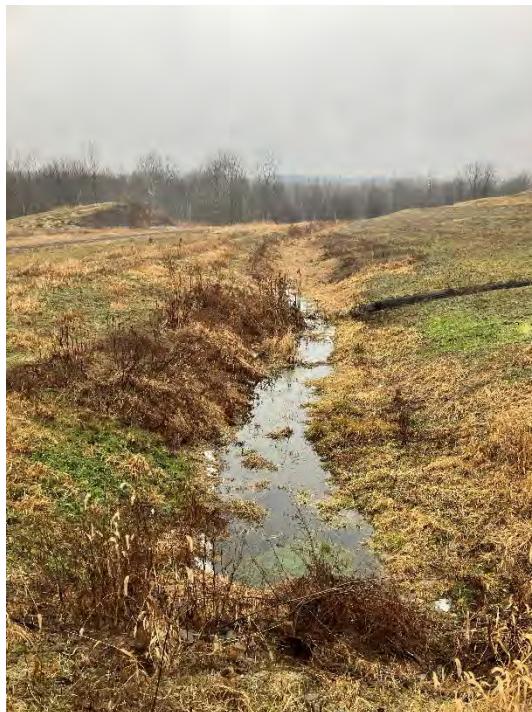
Photograph 12: Non-contact stormwater channel on south slope is clear of obstructions. The final cover south slope is well vegetated and mowed annually. No evidence of animal burrows, erosion, or stability issues.

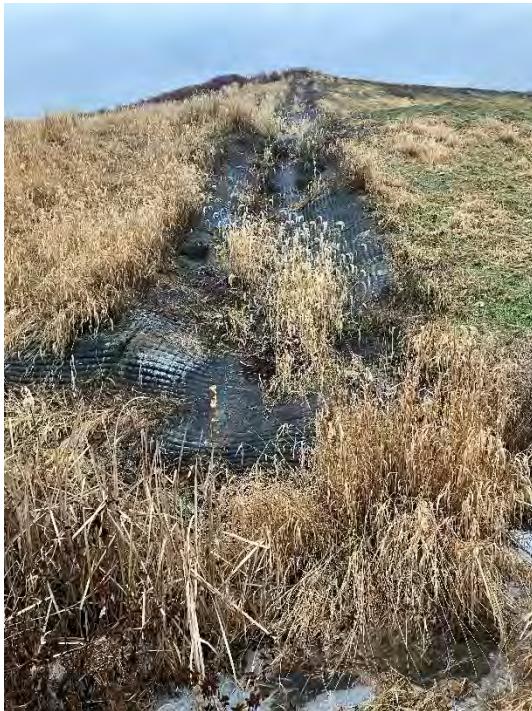
Photograph 13: Non-contact stormwater downchute in southwest corner is clear of obstructions. Gabion energy dissipator is installed at junction with the stormwater perimeter ditch.

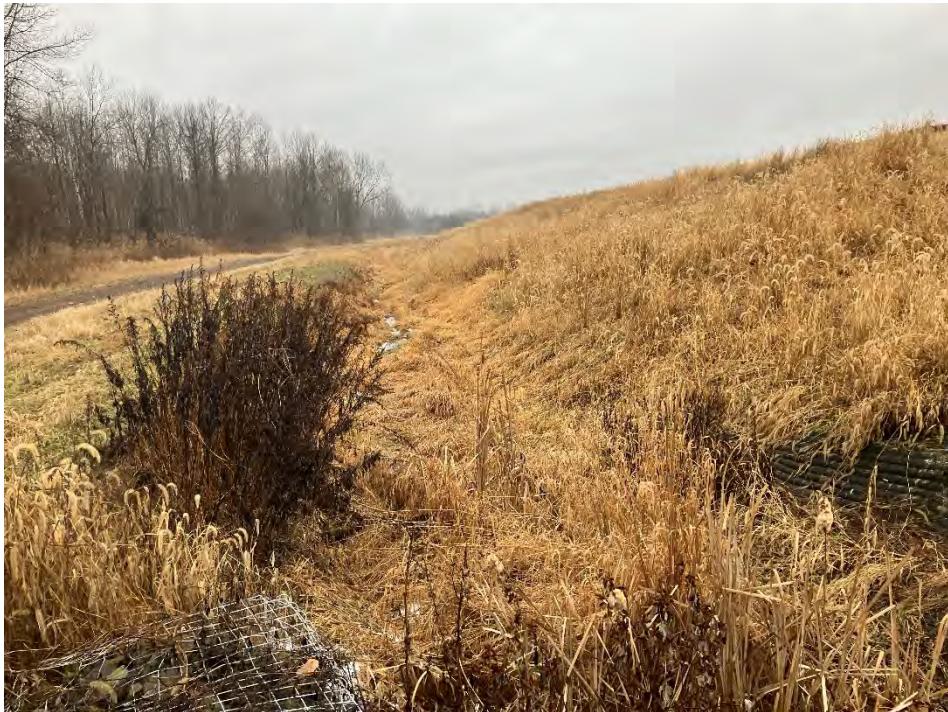
Photograph 14: West non-contact stormwater channel looking north is clear of obstructions. West final cover lower slope is well vegetated and mowed annually. No evidence of animal burrows, erosion, or stability issues.

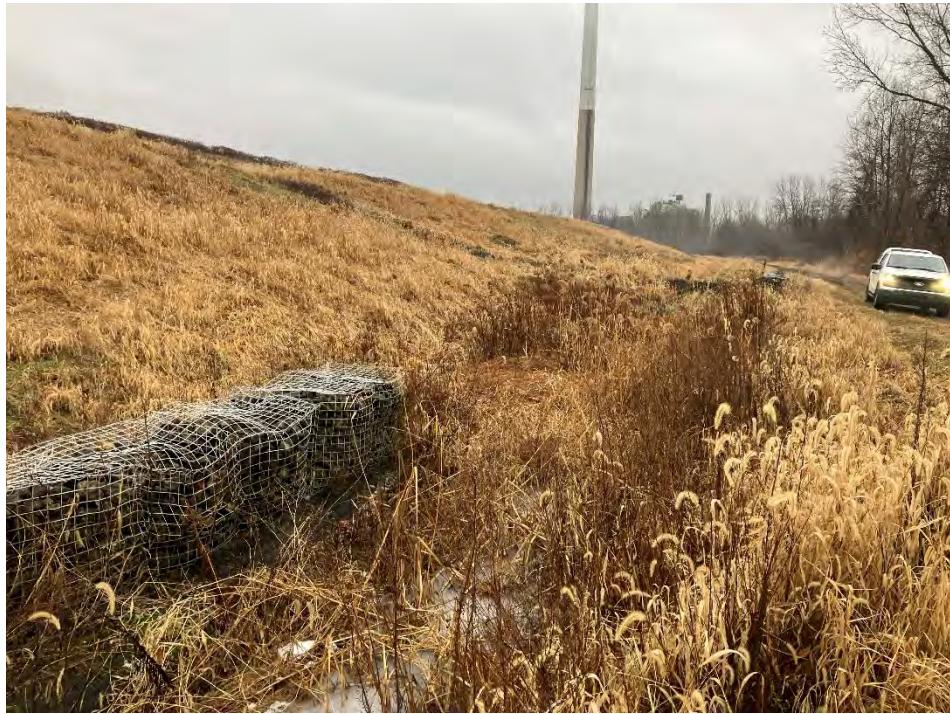
Photograph 15: West non-contact stormwater channel looking south is clear of obstructions. West final cover lower slope is well vegetated and mowed annually. No evidence of animal burrows, erosion, or stability issues.

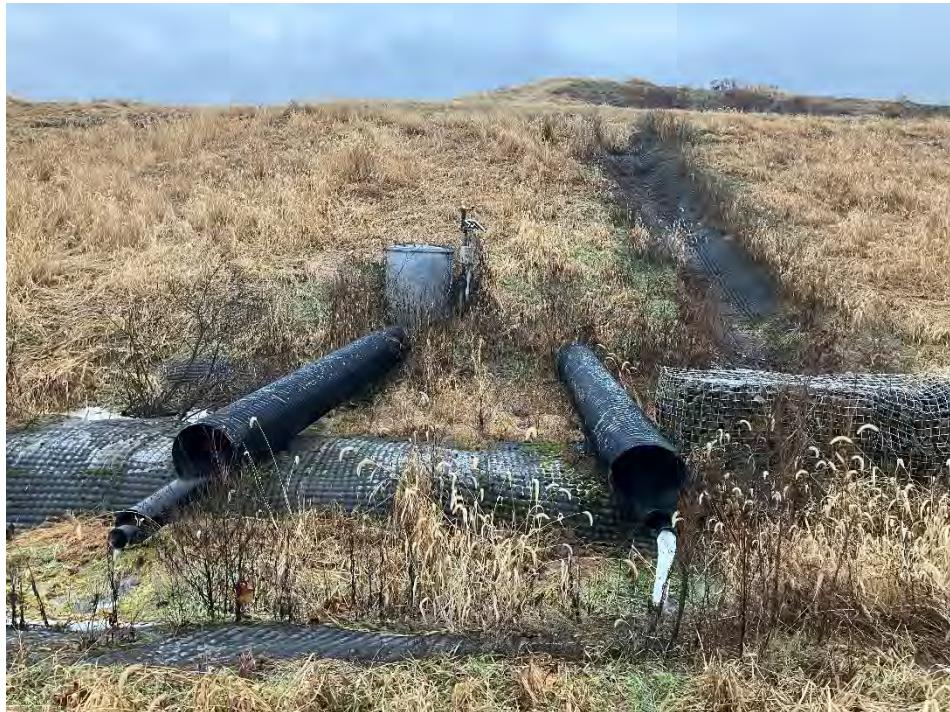
With no evidence to the contrary, the layover liner system at the active Stage 4 disposal area is believed to be in good operating condition and functioning as intended. At the time of the inspection, leachate and stormwater conveyance systems were operating as designed. A leachate leak detection pipe was reviewed during the inspection and was not flowing, indicating that the bottom liner system of Stage 4 is not leaking.

Photograph 16: Leachate collection zone and leak detection zone discharge pipes.

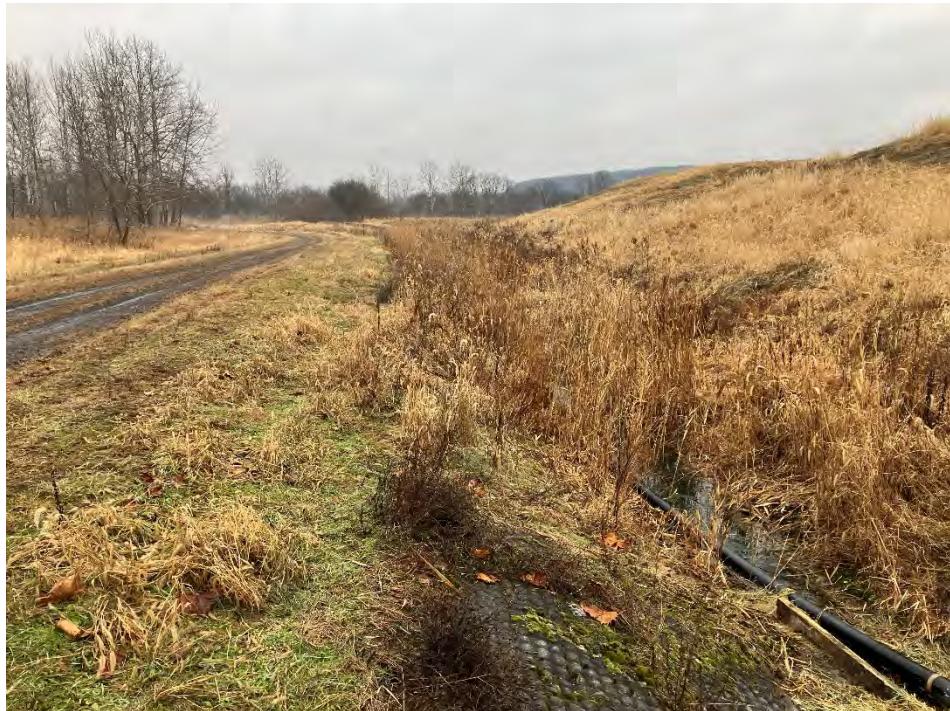
Photograph 17: West non-contact stormwater channel looking north is clear of obstructions. West final cover lower slope is well vegetated and mowed annually. No evidence of animal burrows, erosion, or stability issues.

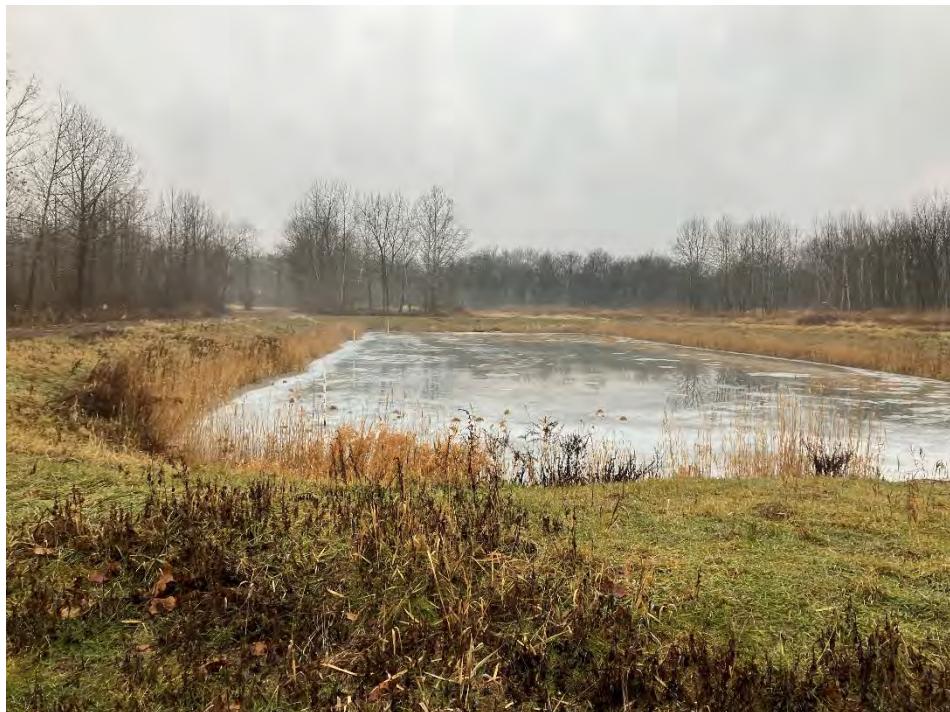
Photograph 18: Leachate (contact water) Pond. No evidence of animal burrows or liner damage.

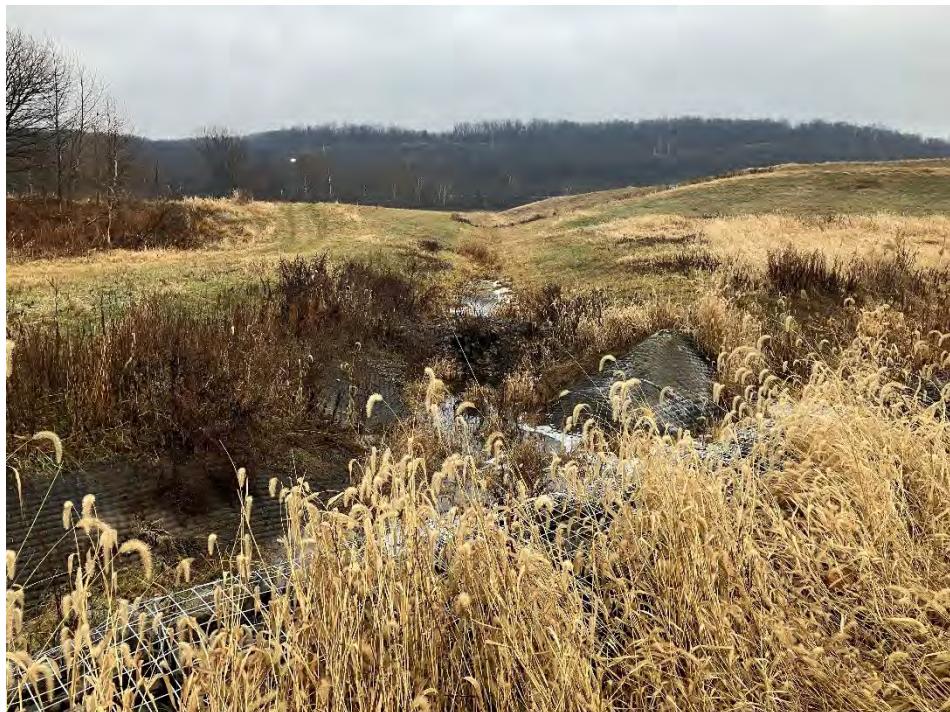
Photograph 20: North non-contact stormwater channel is clear of obstructions. North final cover lower slope is well vegetated and mowed annually. No evidence of animal burrows, erosion, or stability issues.

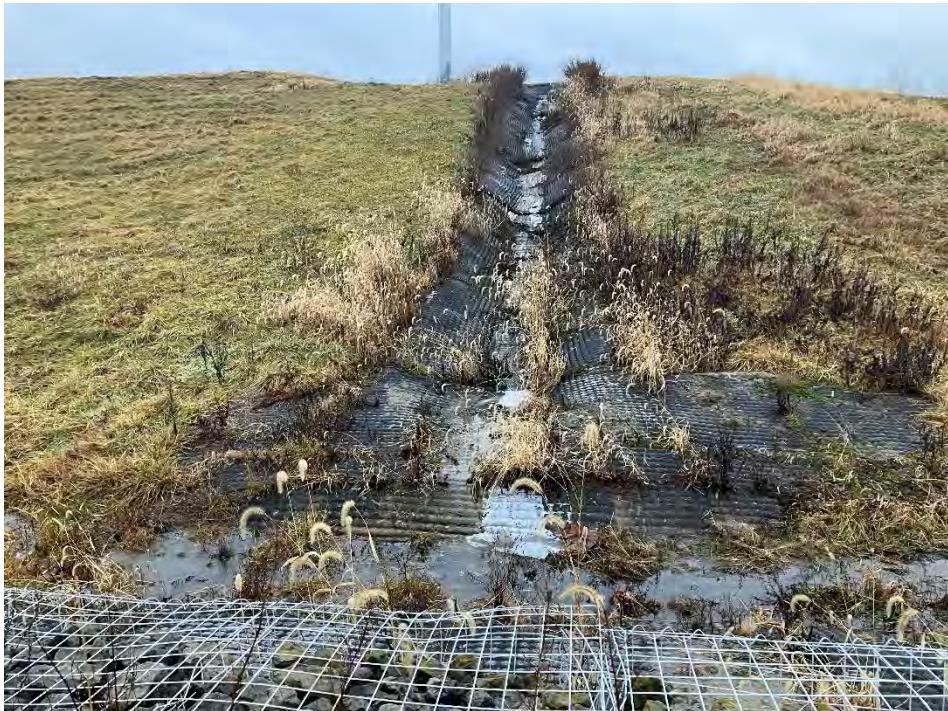
Photograph 21: Non-contact stormwater downchute in northwest corner is clear of obstructions. Gabion energy dissipator is installed at the junction with the stormwater (non-contact water) perimeter ditch.

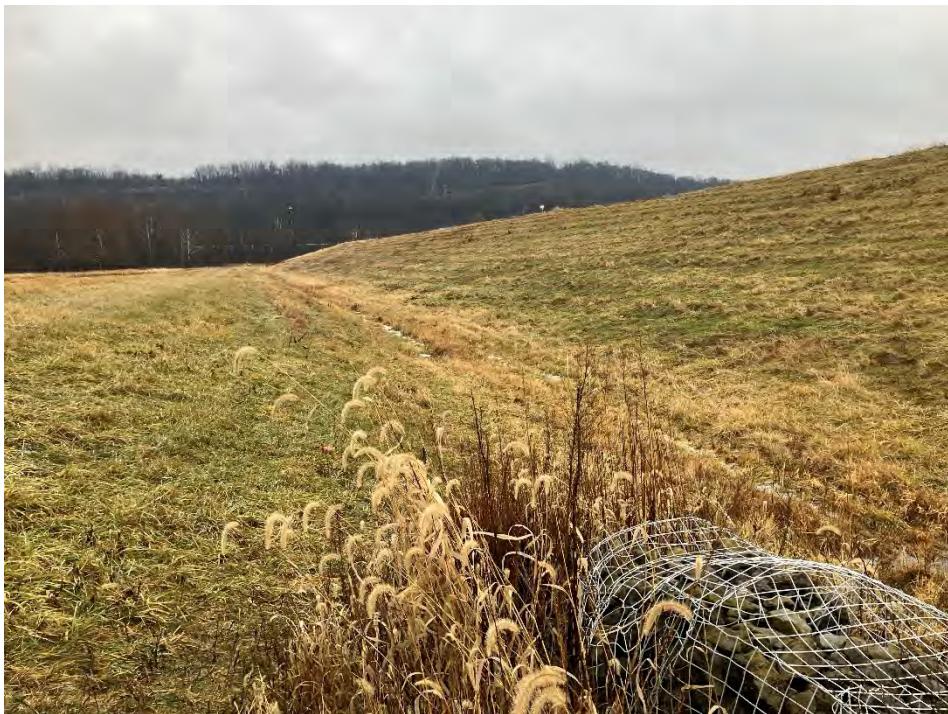
Photograph 22: North non-contact stormwater channel is clear of obstructions. North final cover lower slope is well vegetated and mowed annually. No evidence of animal burrows, erosion, or stability issues.

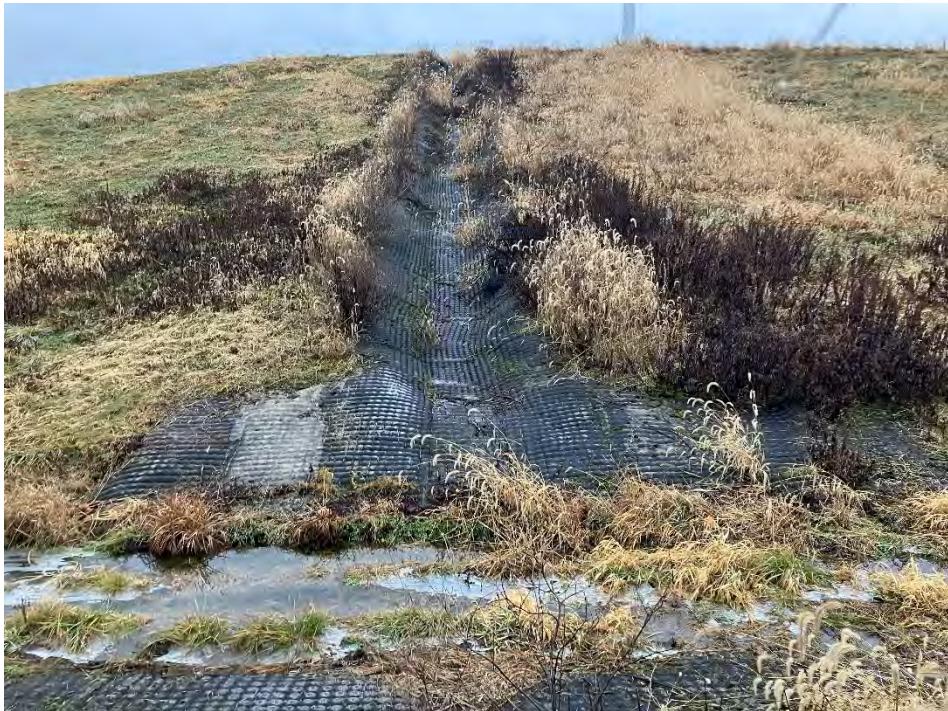
Photograph 23: Non-contact stormwater downchute in northeast corner is clear of obstructions. Gabion energy dissipator is installed at the junction with the stormwater (non-contact water) perimeter ditch.

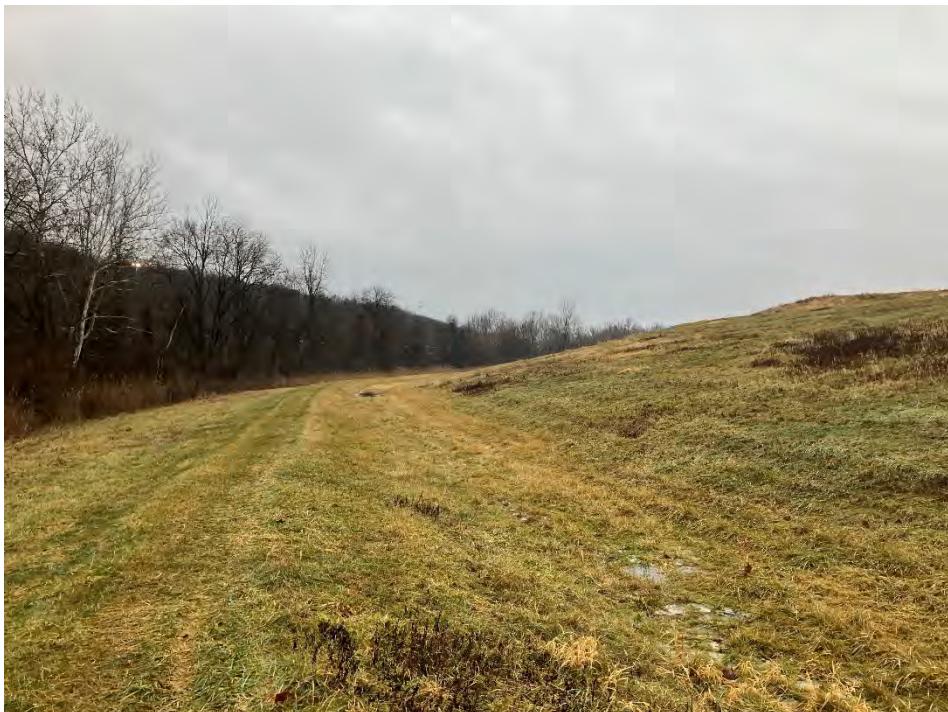
Photograph 24: East non-contact stormwater channel looking south is clear of obstructions. East final cover lower slope is well vegetated and mowed annually. No evidence of animal burrows, erosion, or stability issues.

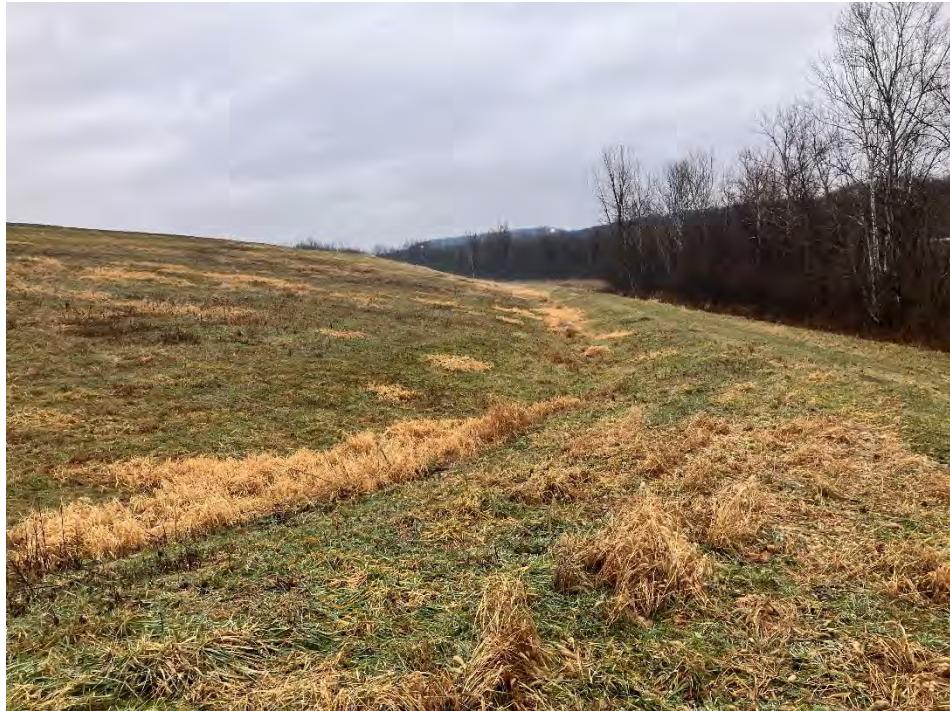
Photograph 25: East non-contact stormwater channel looking north is clear of obstructions. East final cover lower slope is well vegetated and mowed annually. No evidence of animal burrows, erosion, or stability issues.

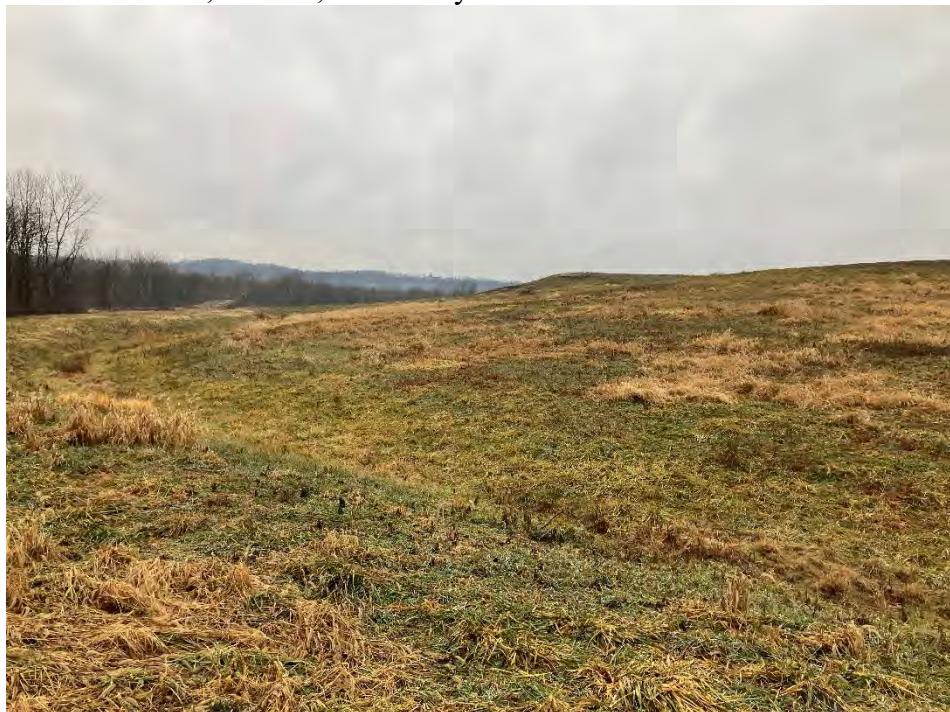
Photograph 26: South non-contact stormwater channel looking west is clear of obstructions. South final cover lower slope is well vegetated and mowed annually. No evidence of animal burrows, erosion, or stability issues.

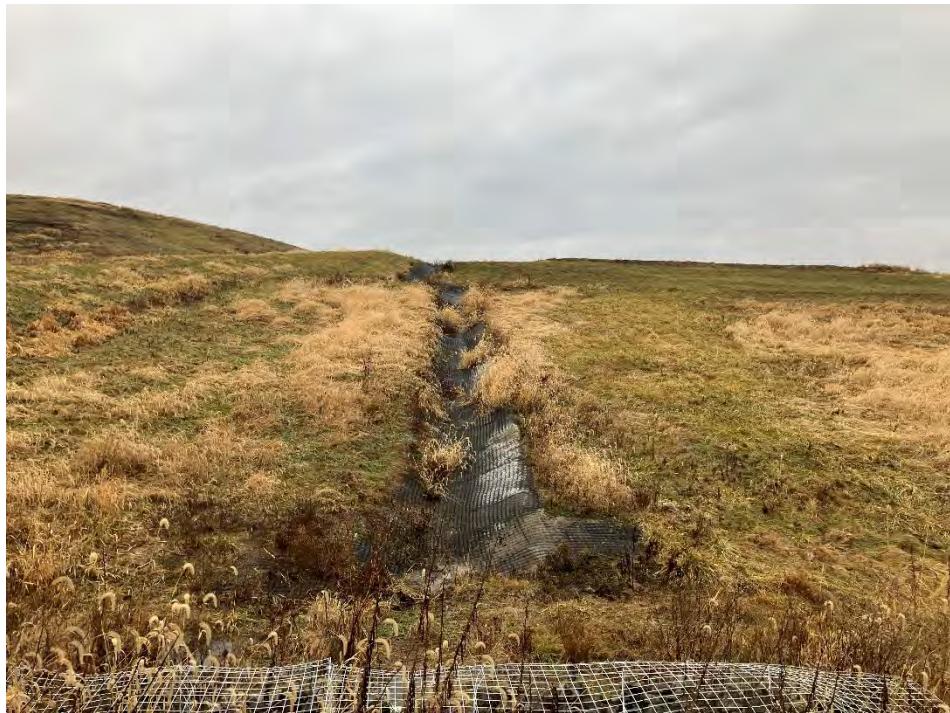
Photograph 27: Non-contact stormwater downchute on south slope is clear of obstructions. Gabion energy dissipator is installed at the junction with the stormwater (non-contact water) perimeter ditch.

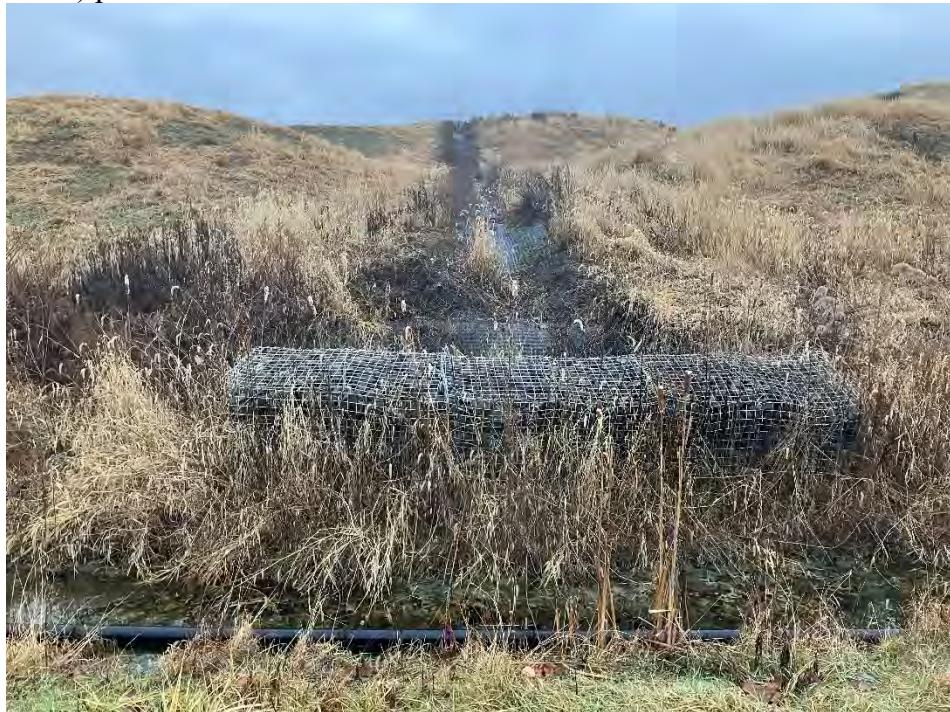
Photograph 28: Non-contact stormwater downchute on west slope is clear of obstructions. Gabion energy dissipator is installed at base of downchute before the stormwater perimeter ditch.
